**GEOTECHNICAL ASSESSMENT REPORT**

**CITY OF CUMMING, GEORGIA  
HIGHWAY 20 SAWNEE TANK SITE  
SLOPE FAILURE  
CUMMING, FORSYTH COUNTY, GEORGIA**

**GeoSystems Project No. 22-2875  
April 5, 2023**

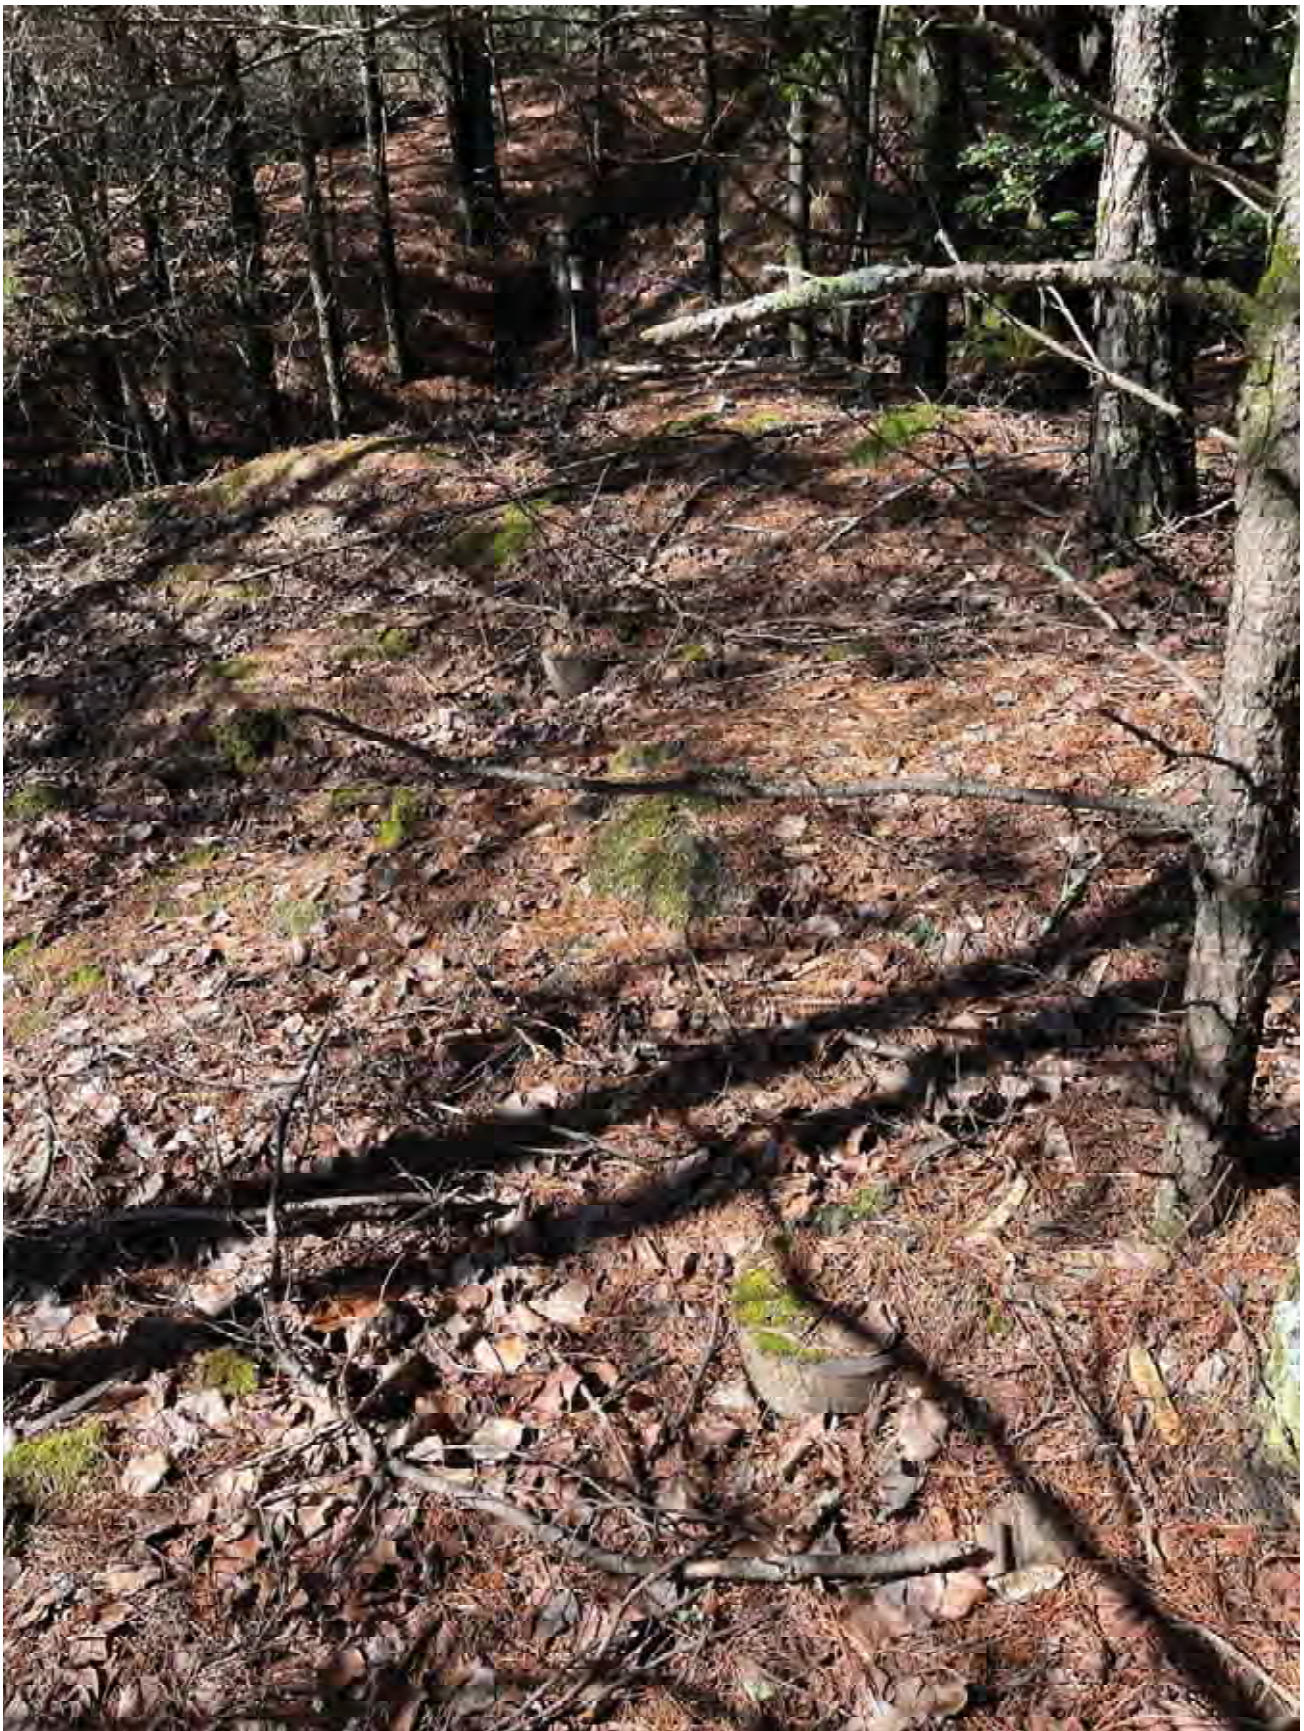
Cast Iron Pipes in Existing Slope Southwest of Failure 02/03/2023

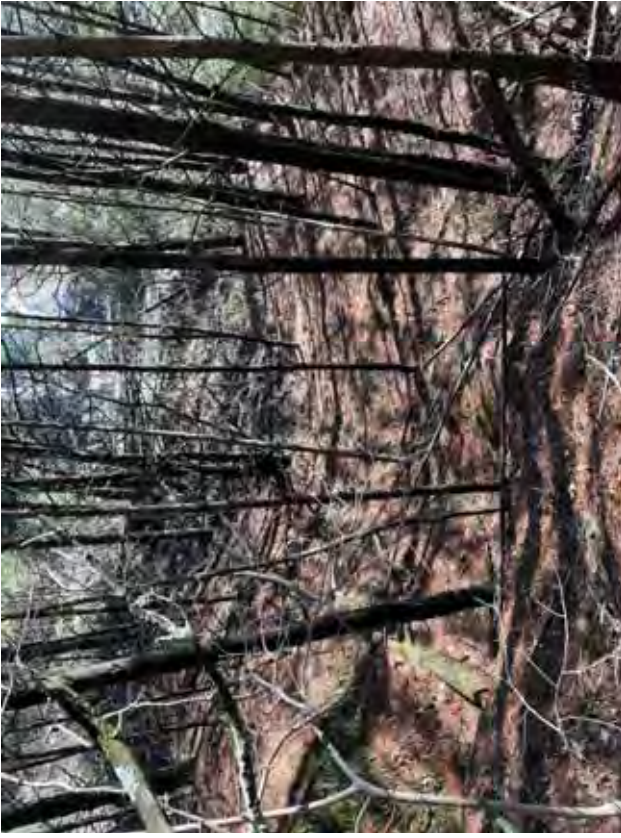
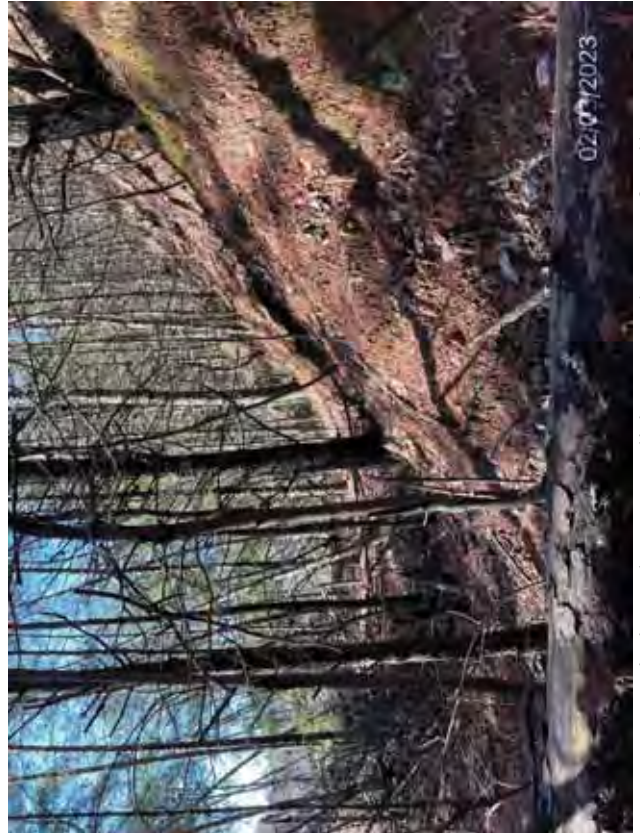
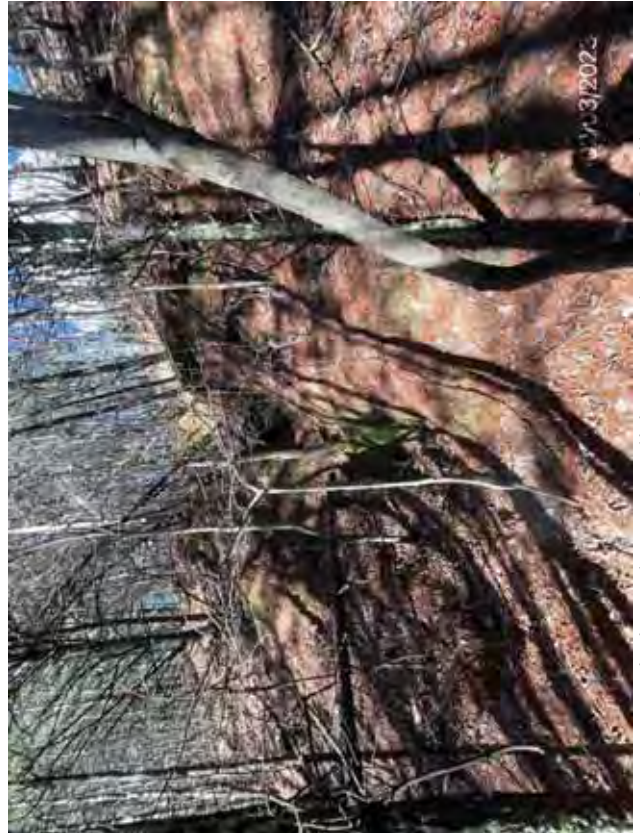
Existing Slope Conditions Southwest of Failure

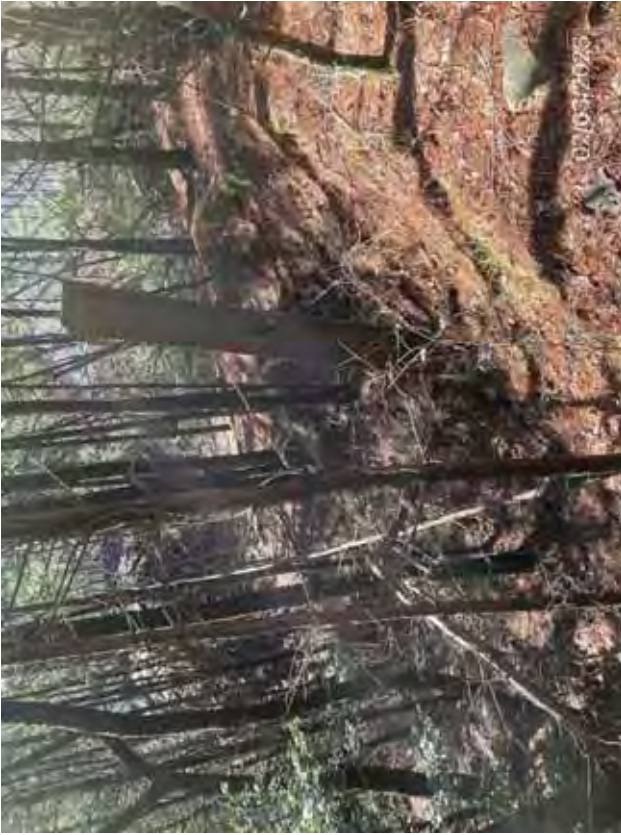
Steel Beam in Existing Slope Southwest of Failure

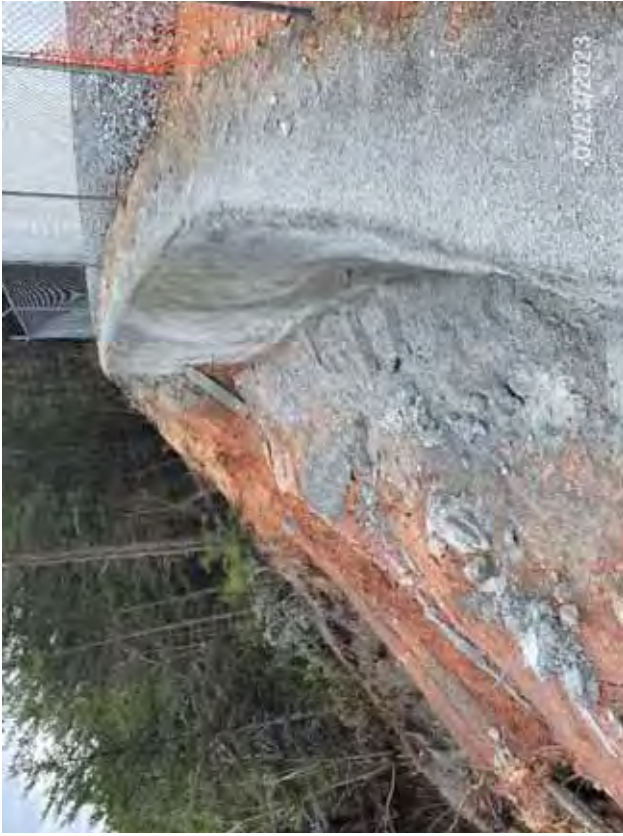
Soil Nail Wall Installed by GSI

As noted in the previous section, GeoStabilization International performed emergency repairs of the upper part of the slope failure. The repair work was initiated during the week of December 19, 2022, and was completed about January 17, 2023. The repairs consisted of the installation of an approximate 100-foot long, 10-foot high permanent, soil nail wall with shotcrete facing. Vertical, grouted micropiles were initially installed on approximate 18-inch centers along the back of the planned wall location. The micropiles extended about 20 feet below the ground surface into undisturbed natural soils. Three rows of soil nails, typically 18 feet in length, were then installed prior to placement of the shotcrete facing. Horizontal drains were incorporated in the wall typically at a spacing of 10 feet, center to center.
